A Rotting Timber Frame

Foam sheathing, too much moisture, and a broken vapor barrier almost spelled disaster for a four-year-old timber-frame house in southern Vermont.

by Steven Bliss

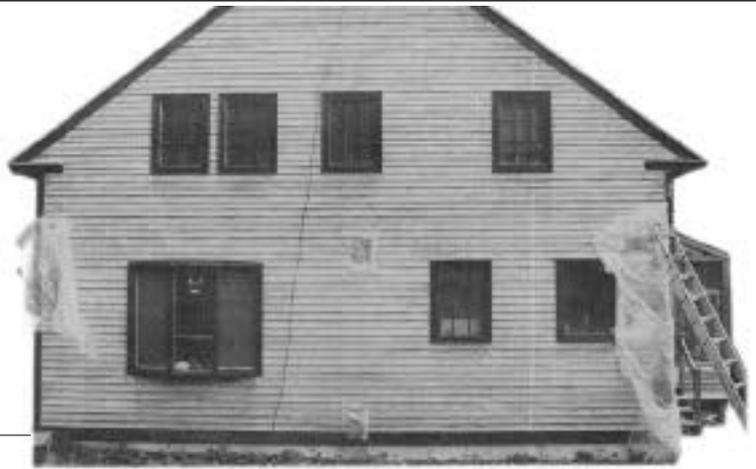
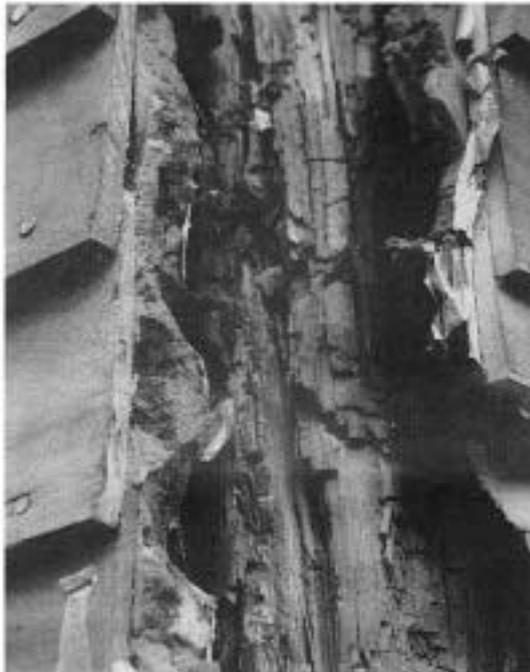
The owner discovered the problem when a renovation contractor opened up the south side of the house in order to add a sunspace. He found extensive decay in and around the timbers. The rot occurred on the outer face of the timbers—up to two inches deep in some sections—and in the sheathing and 2x4s wherever they touched the timbers.

To learn more, the owner cut out sections of siding and sheathing on all sides of the house and found decayed wood on the north, south, and west. Only one hole was cut on the east side, and showed only minor damage.

There was decay on nearly all the beams looked at—high and low, on vertical posts, and on horizontal beams. Rot also occurred in the 2x4s that were directly nailed to the beams, and in the 1x pine sheathing where it touched the beams. No decay was found in the wall sections between the beams, or elsewhere—although a thorough search was not made of all areas.

The west face of the house (above) was cut open in four spots, all revealing severe decay of the timber frame and adjoining wood. The southwest corner (below left) and center holes (below right) are shown close up.

1. Keep household moisture levels down by adding fans and venting the dryer outdoors.
2. Seal the checking in the beams and the gaps around the beams with caulking. Then seal the beams with a clear finish.
3. Replace the foil-faced sheathing at the beams with beadboard to allow some drying at these points.

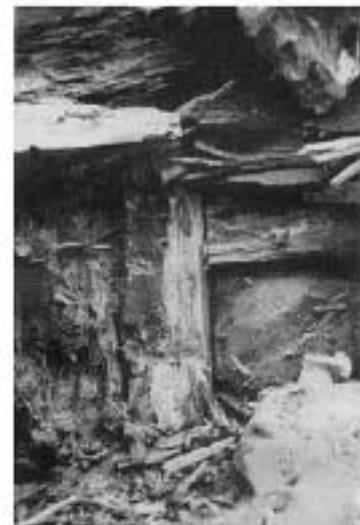
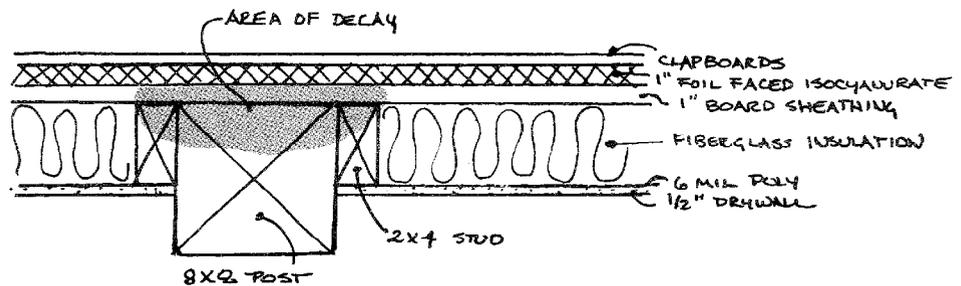
Decay was concentrated on the outer portion of the timbers and the nearby sheathing and studs, as shown in the darkened area.

So what caused the problem? In short, a combination of green wood, a moist house, a cold-side vapor barrier, and a cold climate. The timber-frame, built of 8x8 hemlock beams, had been assembled green in the fall and closed in in the spring. Since wood does not dry well in the cold, it was probably still quite wet when wrapped in foam the following spring. The water in the green wood gave the decay fungi a head start the first year.

Why didn't the beams dry toward the inside of the house over the summer? They did—at least near the inside faces, which became severely checked. But when winter came, the high moisture levels in the house drove the moisture back into the beams toward the sheathing, where it condensed.

The large gaps in the 8x8s provided an easy path for moisture into the wood, which is quite permeable anyway. Moisture could also penetrate the wall along the sides of the beams. Other interruptions in the vapor barrier—at floors, ceilings, and electrical outlets—let more moisture into the wall cavities. The inside face of the foam was below the dew point of the moist interior air throughout much of the winter (see sidebar).

The exposed inside sections of the beams dried, but the wet outer sections festered. Enough water got into the wood each winter so that warm spring temperatures caused decay before the wood could dry out. The foam kept the wood from drying outward, and kept the sun from drying the wood inward. By midsummer, perhaps, the wood fell below saturation levels, stifling decay growth. But the next winter the cycle would repeat.

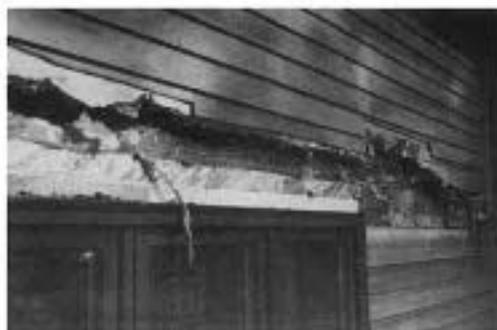
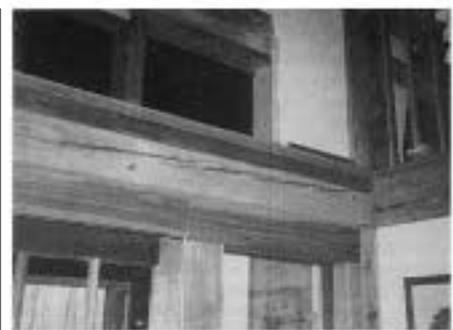
The beams were heavily checked on the inside (right) and rotting on the outside (left).
