A Rotting Timber Frame

Foam sheathing, too much moisture, and a broken vapor barrier almost spelled disaster for a four-year-old timber-frame house in southern Vermont.

by Steven Bliss

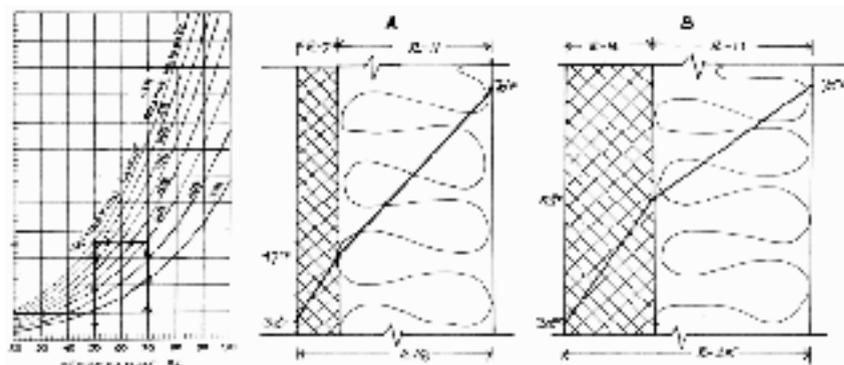
How can you gauge this for yourself? First, you need to calculate the dew point of the interior air during the winter. To be conservative, assume an indoor relative humidity of 50 percent at 70°F. That gives you a dew point of about 50°F, according to the chart.

To find the dew point for any temperature and relative humidity: Start with the temperature, move up to the current relative-humidity line. Move left to the saturation curve, and down to find the dew point, as shown.
